CASE STUDY

# Grinding Burn Inspection Using Barkhausen Noise Analysis

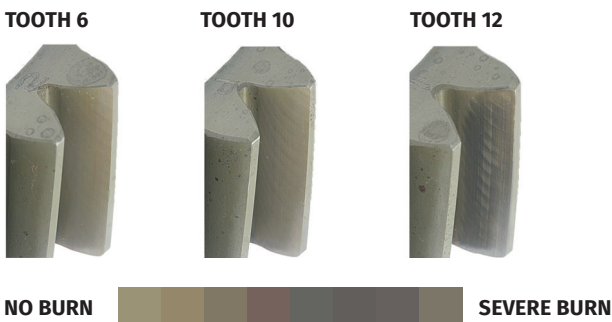
### NITAL ETCH

**TOOTH 6** shows no signs of damage via etch and corresponds to the lowest measured Barkhausen noise values.

**TOOTH 10** shows very little signs damage from etching, yet shows substantially higher Barkhausen noise analysis results as compared to tooth 6 indicating that the tooth was damaged during grinding.

**TOOTH 12** shows clear indications of grinding burn and would not pass visual inspection. As expected, this tooth had the highest measured Barkhausen noise values.

American Stress Technologies worked closely with Company A to demonstrate the effectiveness of Barkhausen noise analysis as an alternative to nital etch inspection. Barkhausen noise is a completely non-destructive magnetic method in which a sensor makes contact with the part and measures the response to an applied magnetic field in real time. The measured signal is sensitive to changes in both stress and micro-structure (hardness). In this case the manufacturer created gear teeth with varying levels of grinding damage by varying feed rates and coolant flow. Barkhausen noise scans were made to create full-field maps of each gear tooth from root to tip and compare to the visual nital etch results. While both methods were able to detect grinding burn, the Barkhausen method provided more quantifiable results with correlating data. Traditional nital etch only provided subjective shades of gray which were difficult to interpret.

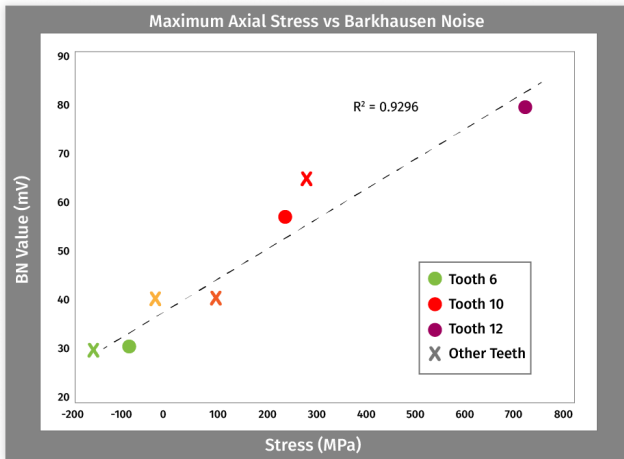
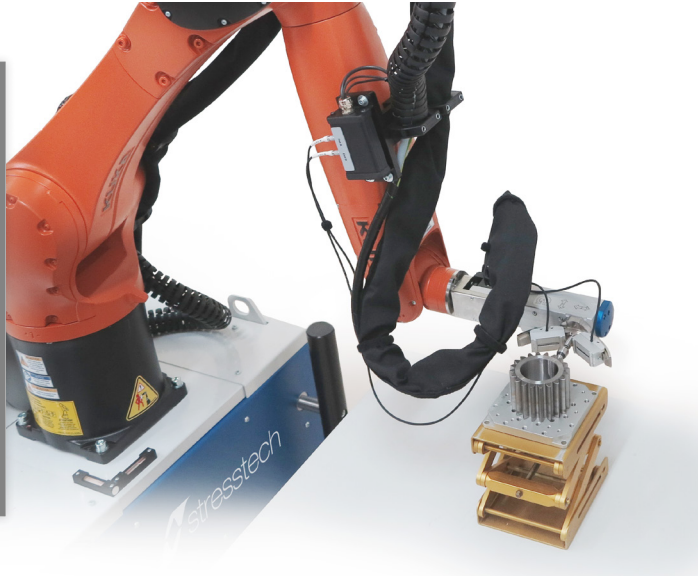
American Stress Technologies performed X-ray diffraction residual stress measurements at the location of the maximum Barkhausen noise analysis measurement value on each tooth. As seen in the plot above, X-ray diffraction results showed that the grinding process had imparted damage with corresponding stresses of nearly 300 MPa in tension on tooth 10 in which the etching looked clean.

Barkhausen noise analysis provided a more sensitive, repeatable, real-time grinding burn inspection without requiring chemicals or consumables. The strong linear correlation between residual stress and Barkhausen noise analysis allowed the manufacturer to determine a quantitative Barkhausen noise rejection threshold based on residual stress magnitudes and design requirements resulting in a more sensitive and reliable grinding burn inspection. The completely non-destructive nature of Barkhausen noise analysis resulted in a substantial cost savings by reducing scrap, and eliminating the need for chemical disposal, and personal protective equipment.
